CASE STUDY

Solid Ring Technology Doubles Packing Life in Application With Dirty Gas

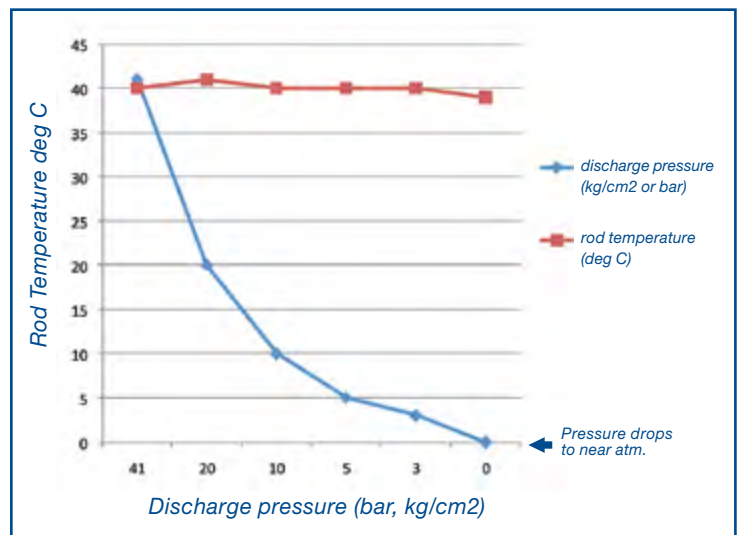
Fig. 1 Estimated discharge pressure and temperature

Each upgraded packing case contains two P1U pressure breaker rings, which are highly effective at preventing debris from entering the packing case. Upgraded cases also incorporate CUU solid ring technology for additional performance benefits. CUU backup rings are uncut. They improve sealing effectiveness, significantly decrease leakage rates and reduce frictional loading against the rod. This ultimately extends packing life by lowering the rod temperature. Figure 1 shows estimated discharge pressure and temperature for the packing configuration. Pressure drops to near atmospheric with no rise in temperature.
